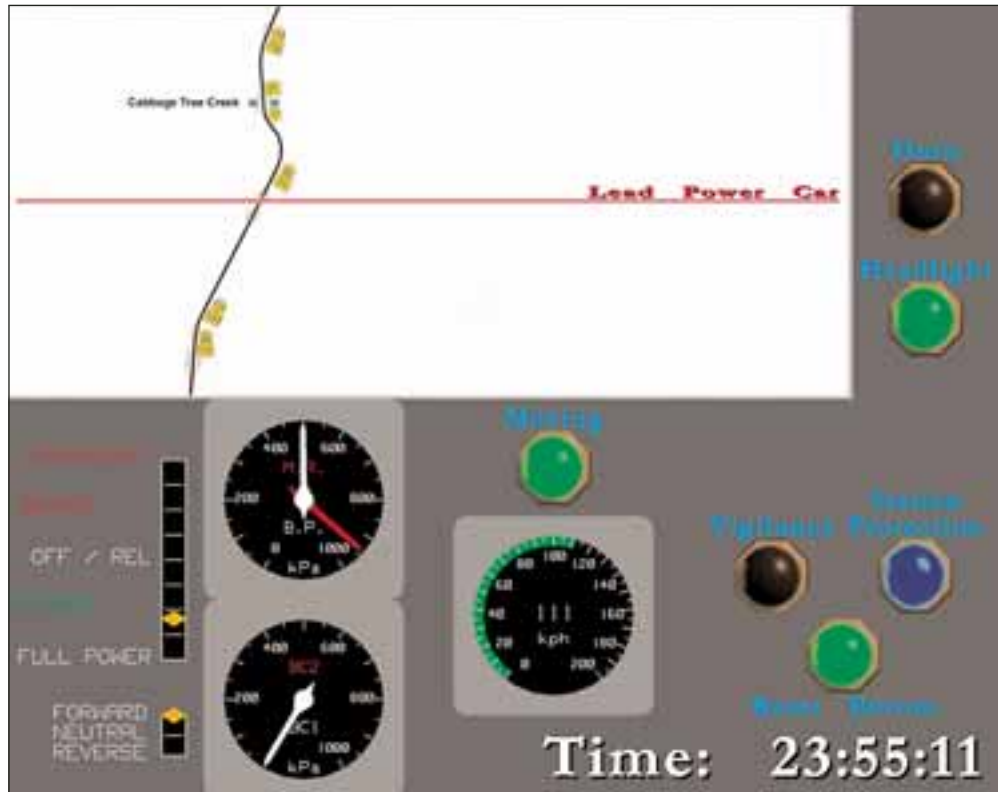
FIGURE 6: Train passes over 'mid-section magnet', driver acknowledges alarm

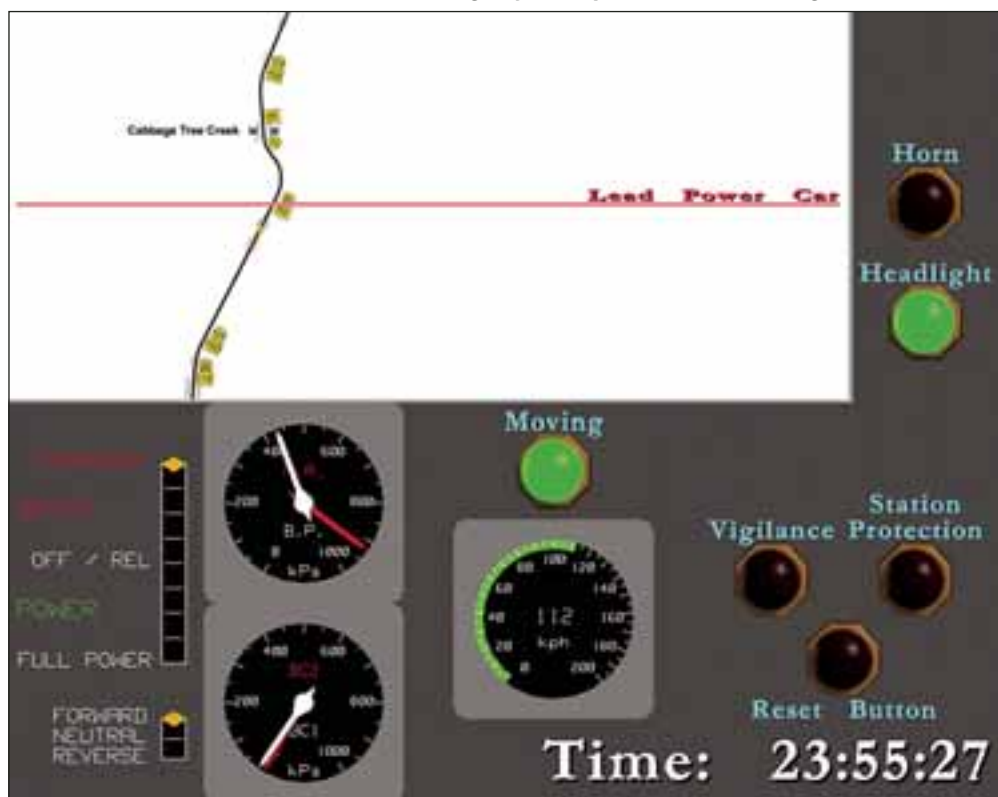
FIGURE 7: Power/Brake Controller in full emergency brake position, train travelling at 112 km/h

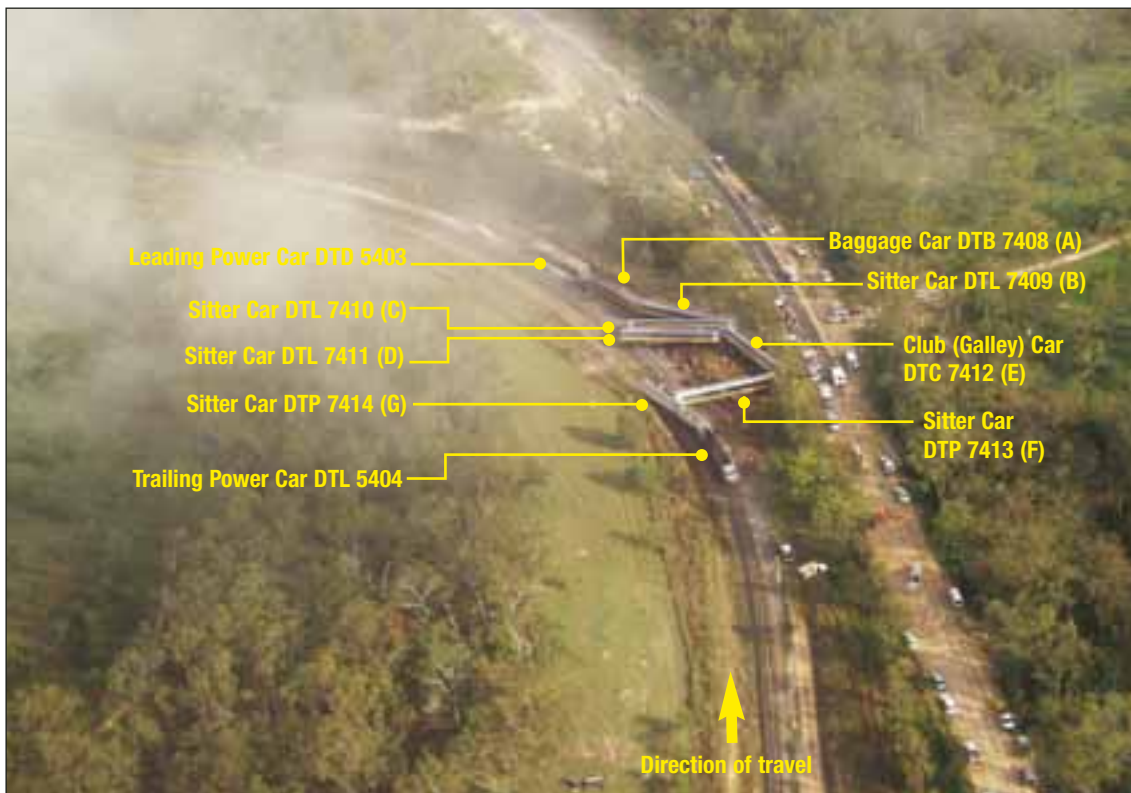
The train rapidly decelerated as the leading power car rolled to the right, leaving the tracks and dragging the remaining trailer cars off the track (Fig. 8, 9 & 10). During the derailment sequence the train collided with three overhead power support poles. From all available evidence, VCQ5 derailed 419.493 km from Brisbane (Roma Street) on the first of the 60 km/h curves in advance of Cabbage Tree Creek travelling at a recorded speed of 112 km/h.

The power car skidded on its right side coming to a stop 108m from the point of derailment. Car 'A' came to rest parallel to the track. Car 'B' slewed so that it was at an angle of about 40 degrees to the line of travel. Cars 'C' and 'D' jack-knifed and were virtually at right angles to the track. Car 'E' came to rest parallel to the track but displaced by between 15m and 20m, probably as a result of the derailing dynamics of the cars in front and behind. Car 'F' was also at right angles to the track, while car 'G' was to the left side of the track. The trailing power car came to a stop aligned slightly to the left of the direction of travel with its leading bogie derailed. With the exception of cars 'A' and 'B' all cars became detached and the trailing power car was the only part of the train to remain upright.

FIGURE 8: Aerial photograph of accident site, showing relative position of power car and trailer cars

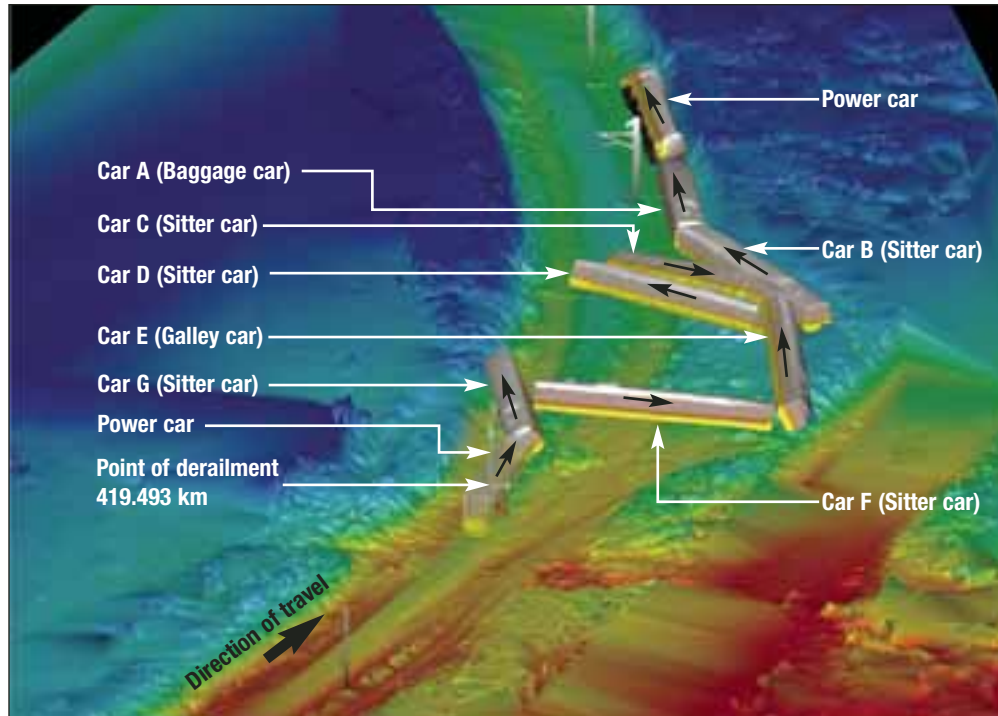
FIGURE 9: Laser survey scan, showing relative position of power cars and trailer cars

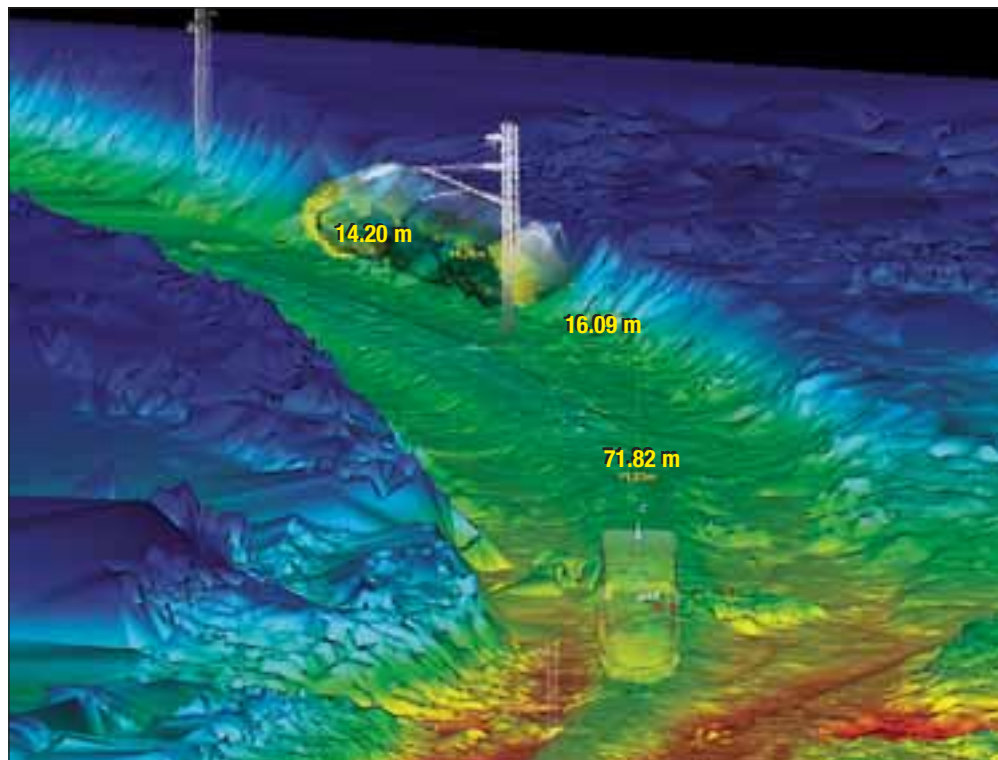
FIGURE 10: Laser survey scan, showing general skid line of power car 5403

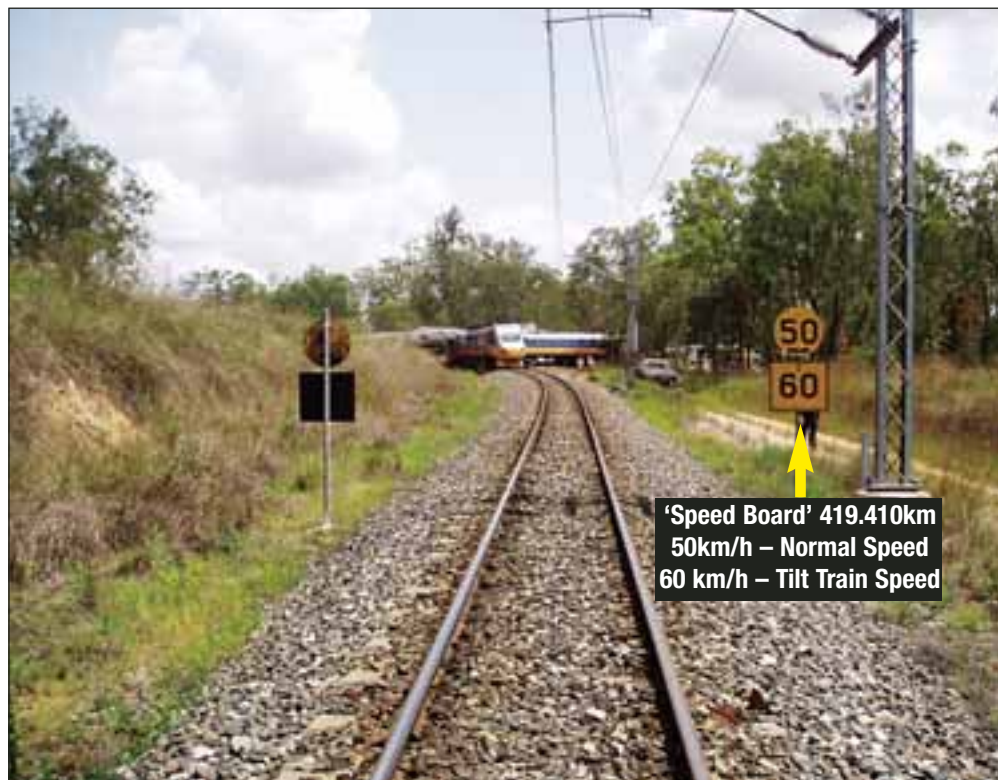
Speed boards on the North Coast line should be erected in accordance with QR standard SAF/STD/0015/CIV. At the 419.410 km site, the style and location of the speed board is as gazetted in QR Weekly Notices 44/98 and 45/98. It designates a limit of 50 km/h for normal trains (circular disk), on top of a 60 km/h limit for tilt trains (rectangular board), see Figure 11.

FIGURE 11: 'Speed Board' at 419.410 km

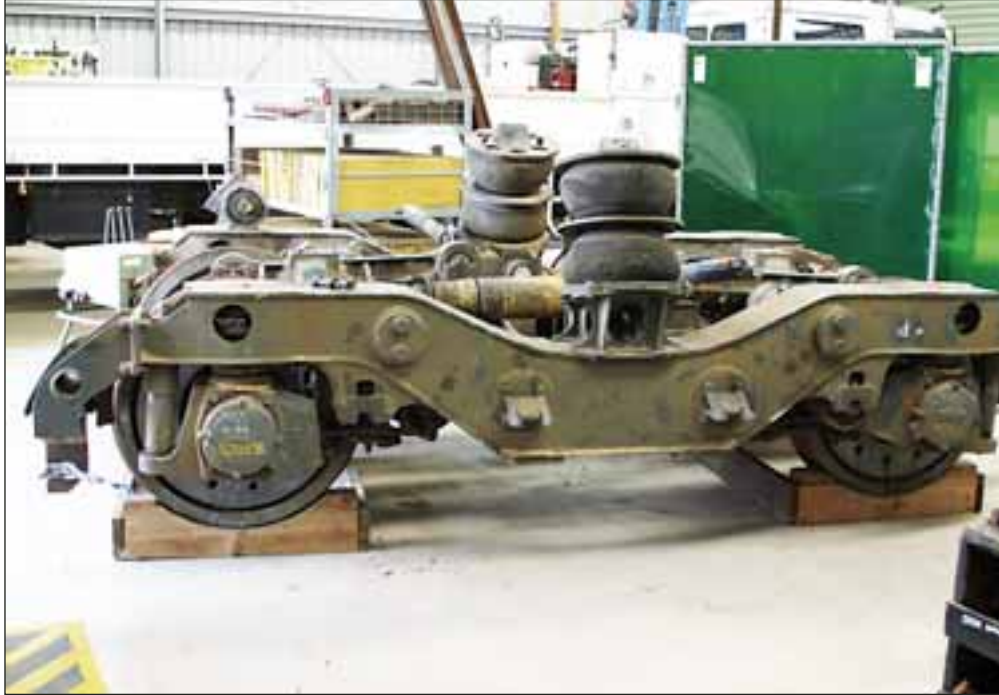
- e) A metallurgical inspection of the trailing arms (swing arms) on the leading axle of the lead power car, front bogie (No. M52003) see Figure 12 & 13. During preliminary inspections, site investigators noted that both trailing arms had fractured. Initial concern resulted in the temporary withdrawal from service of the remaining CTT.

FIGURE 12: Power Car 5403 bogie M52003

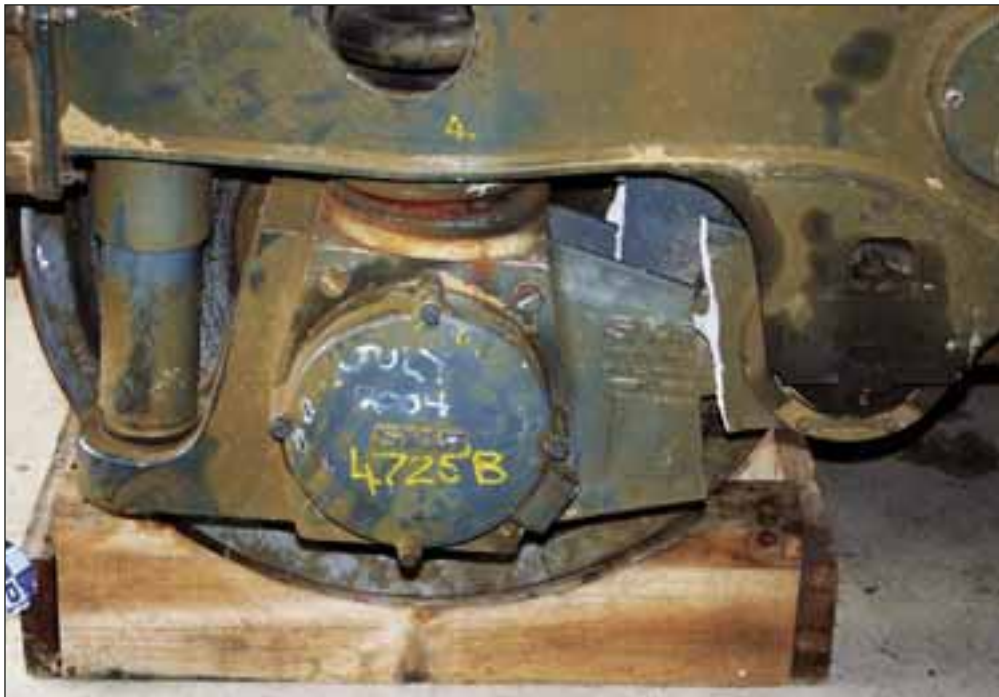
- The fractures of both leading axle trailing arms from bogie M52003 were typical of a brittle fracture mechanism induced by rapidly applied overload conditions.
- The orientation of the fractures on the arms was consistent with the likely forces sustained by the bogie and axle assembly during the derailment event.
- Neither trailing arms showed any evidence of prior or pre-existing cracking or other physical defects that may have predisposed the arms to failure in the manner sustained.
- Neither trailing arms showed any evidence of having failed or being defective prior to the derailment event.
- The arm material met the mechanical and chemical requirements specified by the manufacturer and is considered fit for purpose.

FIGURE 13: Fractured trailing arm – leading axle, left side

It was therefore concluded that the fractures occurred as a consequence of the derailment, that is as a result of the accident and did not contribute in causing the accident.

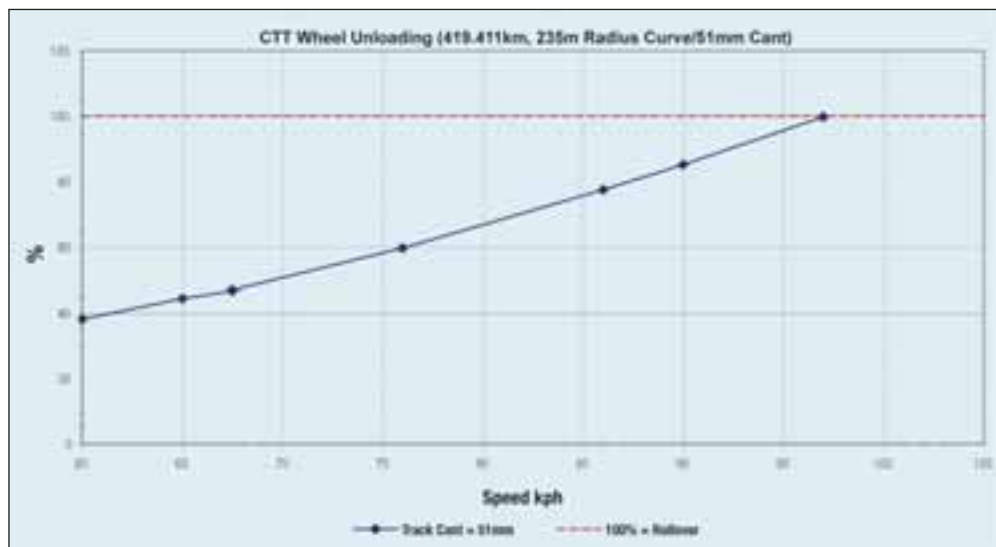
As there was no evidence to suggest that there was a malfunction in the rollingstock or infrastructure, the evidence points to excessive train speed as the most likely cause of the derailment.

FIGURE 14: Wheel Unloading vs Speed

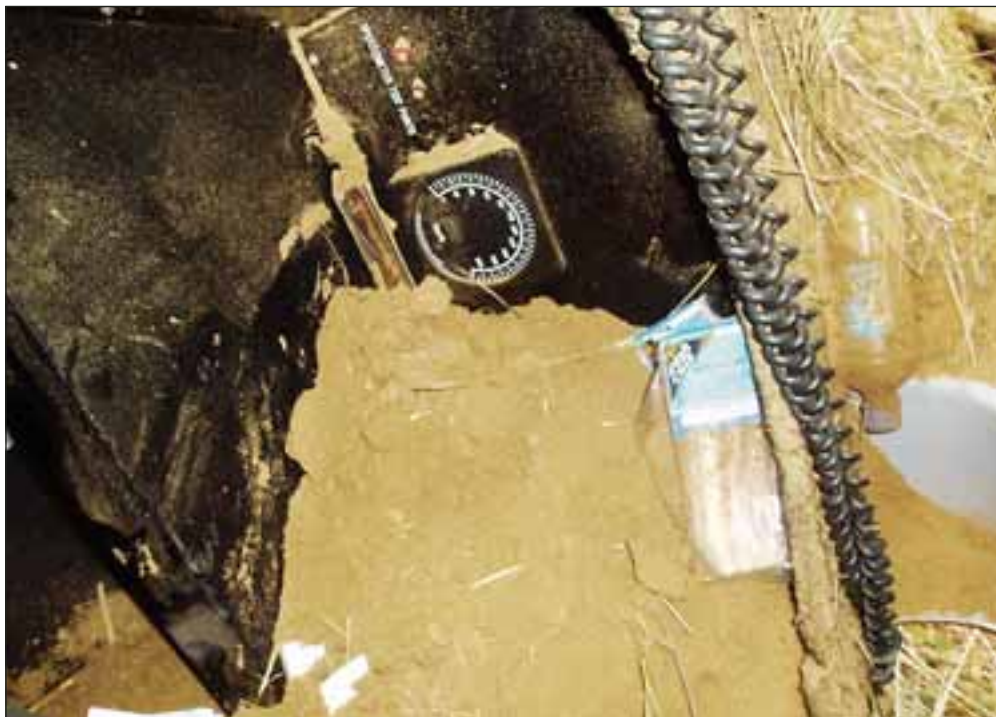
It is possible that having become disorientated and then resetting the alarm, the driver believed he had passed the critical curve at 419.411 km. Following this he may have decided to access his bag and/or get some food from the mini fridge located directly behind the co-driver's position. It is known that the driver was anticipating a 'brew'. It is natural for food and beverage to go together and it is quite possible that the association caused the driver to desire a food pack. He could not access his bag and/or the food pack without leaving the driving seat. If the driver left the seat for sufficient time, just a few seconds and resumed his driving position the train would have been very close to the 60 km/h curve. The finding of two loose packets of 'ham and tasty cheese' sandwiches and a bottle of water in the driver's cab during examination of the accident scene lends some weight to this possibility (Fig. 15)

FIGURE 15: Photograph showing two sandwich packages and bottled water in drivers' cab

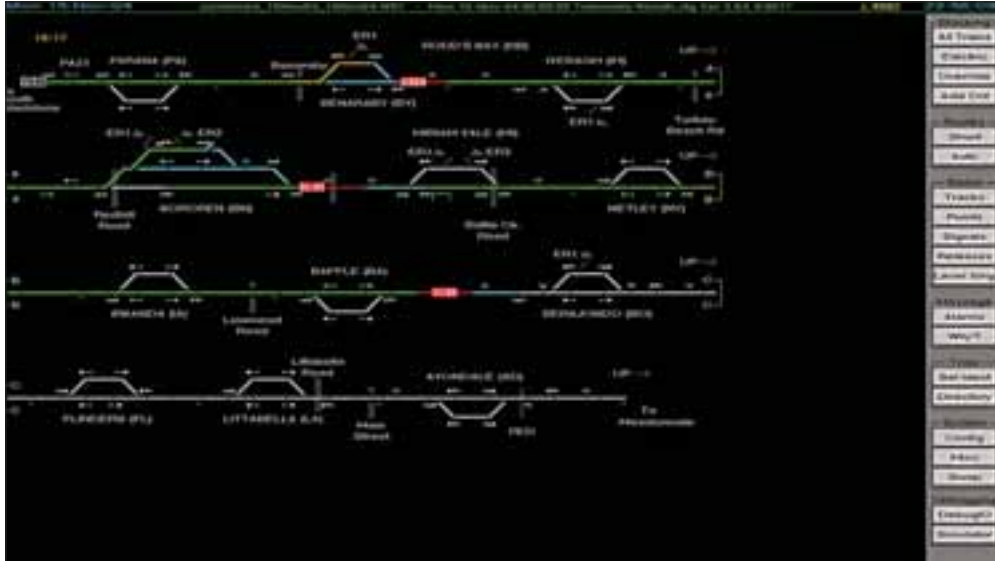
FIGURE 16: Graphics Overview, UTC Workstation 1 – Replay Screen, 2356:09

The replay files pertinent to this derailment were extracted from UTC workstation 1 with relevant information being analysed to identify whether there were any unusual occurrences in the lead-up to or during the accident. A review of this data has established that there were no abnormal events.
